# MAIN PROBLEMS OF REPAIRING ARCHITECTURAL ELEMENTS OF A RAILWAY FLYOVER BUILT IN 1905-1914 WITHIN THE CITY OF GORZÓW USING DRY-MIX SHOTCRETE TECHNOLOGY

Józef **Jasiczak**, Poznan University of Technology, Poznan, Poland  
Włodzimierz **Majchrzak**, SPB TORKRET, Poznań, Poland  
Włodzimierz **Czajka**, SPB TORKRET, Poznań, Poland

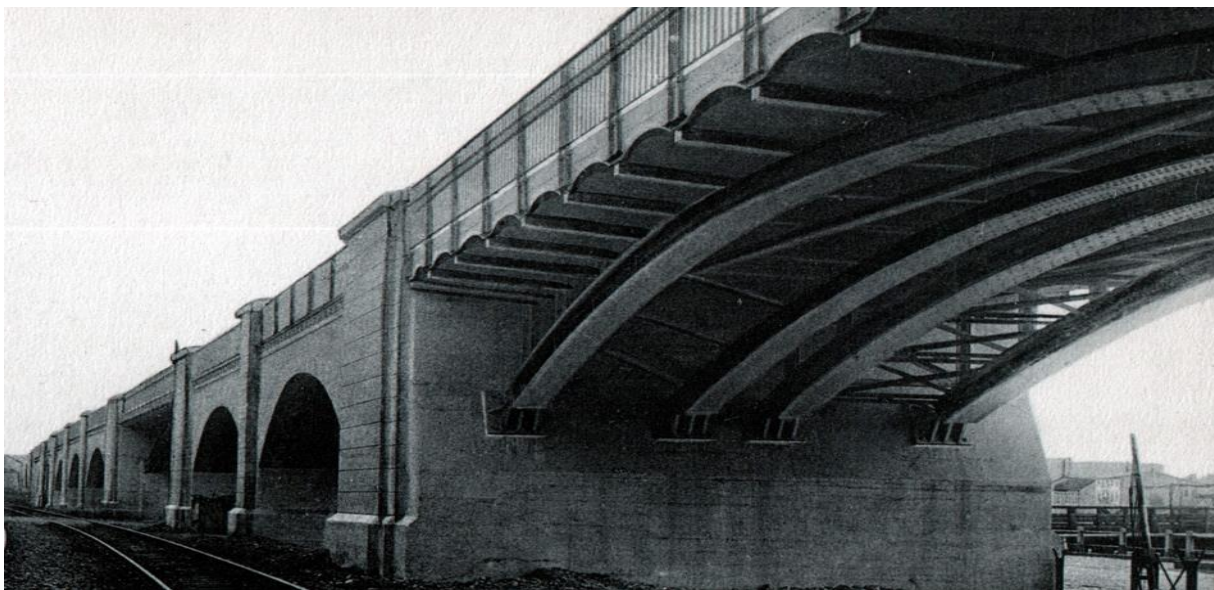
Figure 1. General view of the flyover with concrete and steel brick spans - Photo arch. 1914.

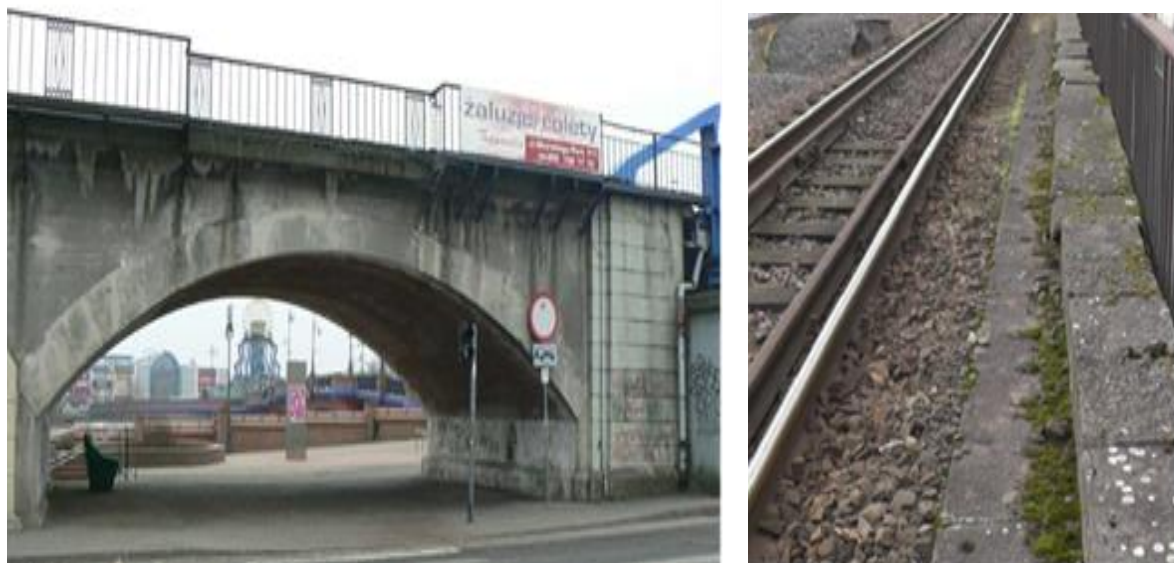
Figure 3: View of a typical open brick-concrete bay and the original railway track with a cornice and steel railing

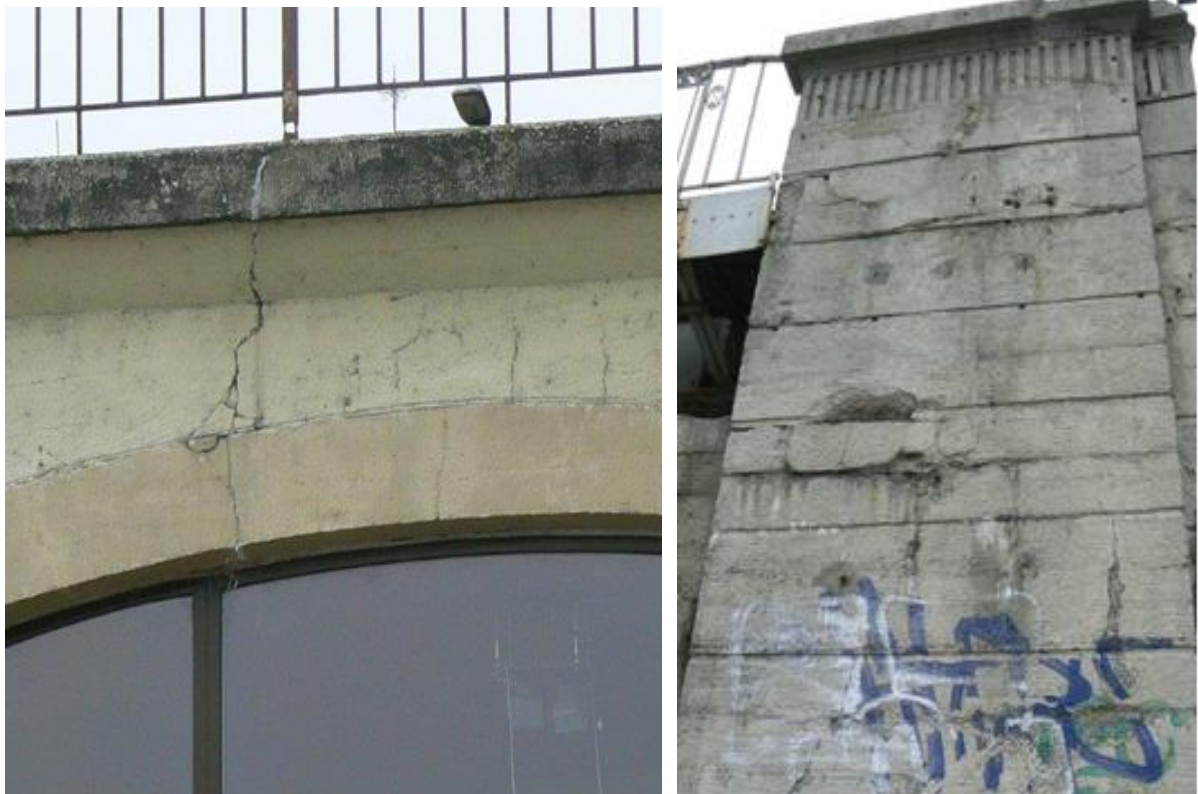
The condition of most elements of the flyover and the station has been determined in the technical expertise developed over the past years as very bad, and sometimes in emergency. This applies to both structural components and finishes that determine the aesthetics of the entire premise. This paper refers to the state of these finishing elements - facade of walls and arcades, arcade vault surfaces, platform and tunnel finishing elements. These are the primary elements constituting, equally with their construction, the historical and aesthetic value of the object. Selected solutions and their technical condition are shown in Figures 3, 4 and 5. Numerous stains on the facade and salt efflorescence on the stone vault as well as material defects and scratches of both the concrete arch and the brick vault are visible. Rustication on supports is cracked, wet and often on large, detached surfaces from the wall.

*Figure 4: Cracks in the brick and concrete arch and supporting elements*

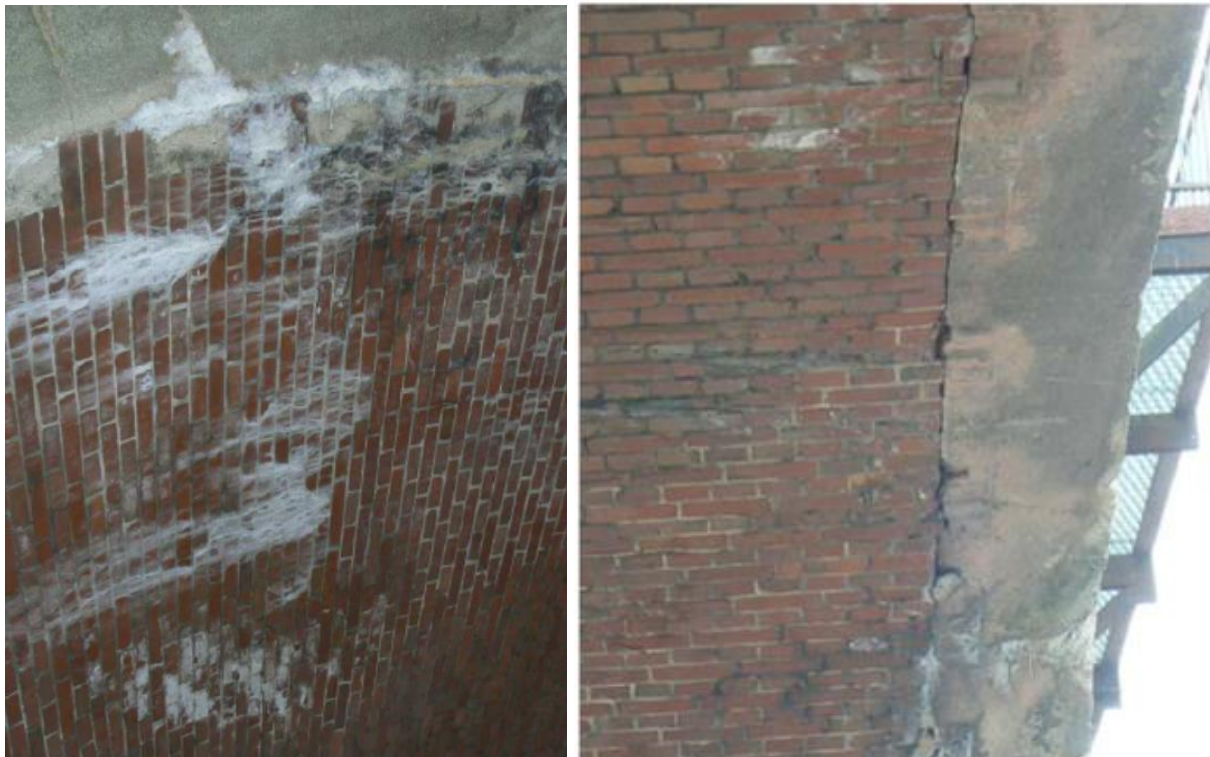
*Figure 5: Brick vault and concrete arch end (bottom view). Leaks, efflorescence, defects in bricks and concrete, cracks on a concrete arch*

Repair of brick arches constituted a separate technological line and included: removal of the insulation layer together with layers of protective concrete over the arches; injection of cracks and scratches with an opening greater than 0.2 mm, bonding of detached concrete side walls from brick vaults (see Figure 5) by means of injection; joining of brick arches with a concrete jacket by means of  $\varnothing$  12 mm rods glued onto the resin; supplementing defects in the vaults with brick identical in terms of dimensions, surface appearance and shape with bricks embedded on a cement-lime mortar with a grain size of 0-4 mm; pointing of repaired vaults. Minor defects of bricks were masked with a properly selected mineral putty imitating the surface of bricks and artificial stone veneers in primary colors.

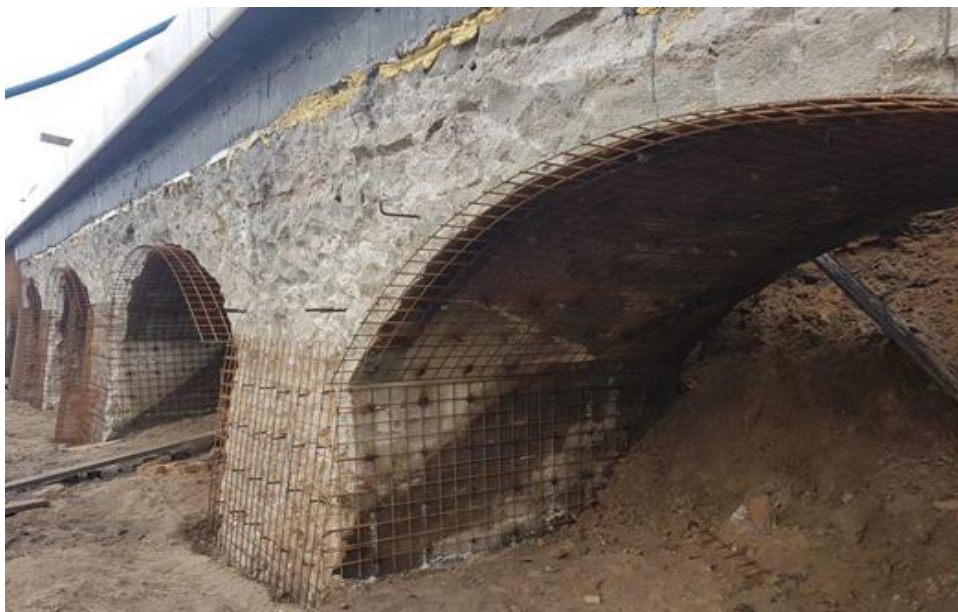
Figure 6: View of the spans after removal of old concrete and mounting of reinforcing mesh

The prepared substrate was covered with mesh of Ø8 mm rods with 100x100 mm mesh width, fixed to the surface of supports and concrete vaults with Ø12 mm anchors glued in to 14 mm holes with a spacing of 0.3x0.3 m. Preparation is illustrated in Figs. 6, 7, 8, 9 and 10 (left). On all exposed concrete surfaces, after preparing the substrate in the manner described earlier a dry-mix sprayed layer was applied at least 0.06 - 0.08 m thick from ready-mixed mixtures of min. C25 / 30 class of concrete. Shotcrete was made in dry-mix technology using the ALIVA 246 machine. The shotcrete mixture was designed with quartz aggregates 0 – 4 mm, Portland cement CEM I 42.5 R, a small amount of fly ash, active silica fume SiO<sub>2</sub> and a small amount of Sika's non-alkaline Sigunit 49 AF setting accelerator. Samples for determining the compressive strength of concrete were made on 600 x 600 mm panels and sent to the laboratory. All of them met the strength criterion.

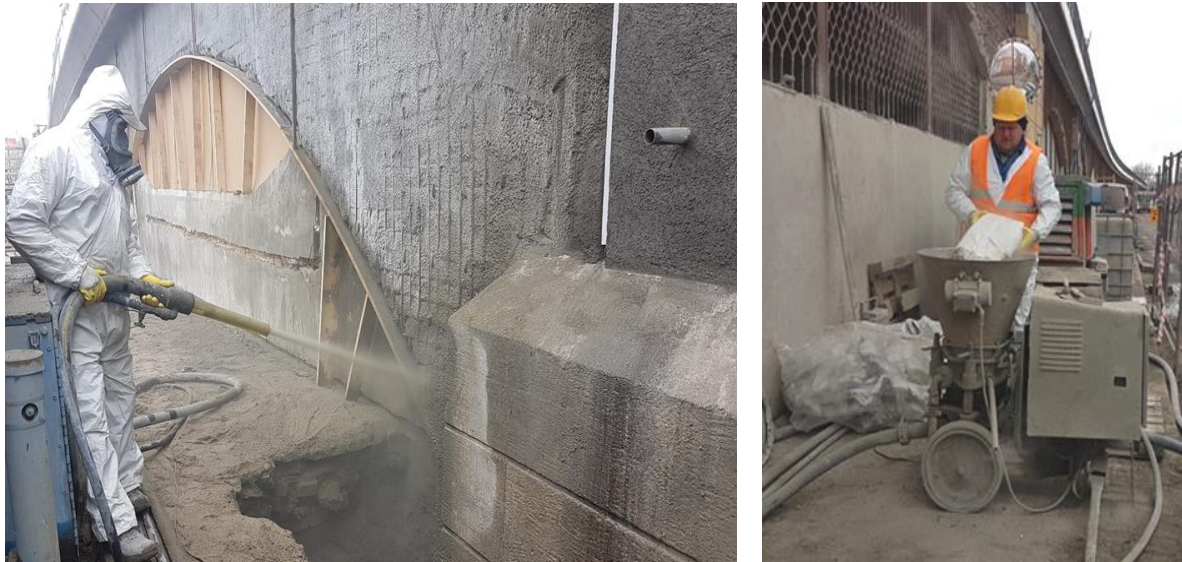
Figure 7: Spraying the second layer of shotcrete (reinforcement cover 3 cm). In the right the ALIVA 246 machine

The concrete mix was applied in two stages: first, a layer of shotcrete for embedding reinforcement was sprayed and then a second layer of shotcrete to obtain a reinforcement cover of 30 mm. The adhesion of the applied layers to the substrate by the "pull-off" method was also checked. Results obtained in the range of 1.0 - 1.5 MPa, which is consistent with the requirements of *PN-EN 1504: Products and systems for the protection and repair of concrete structures*.

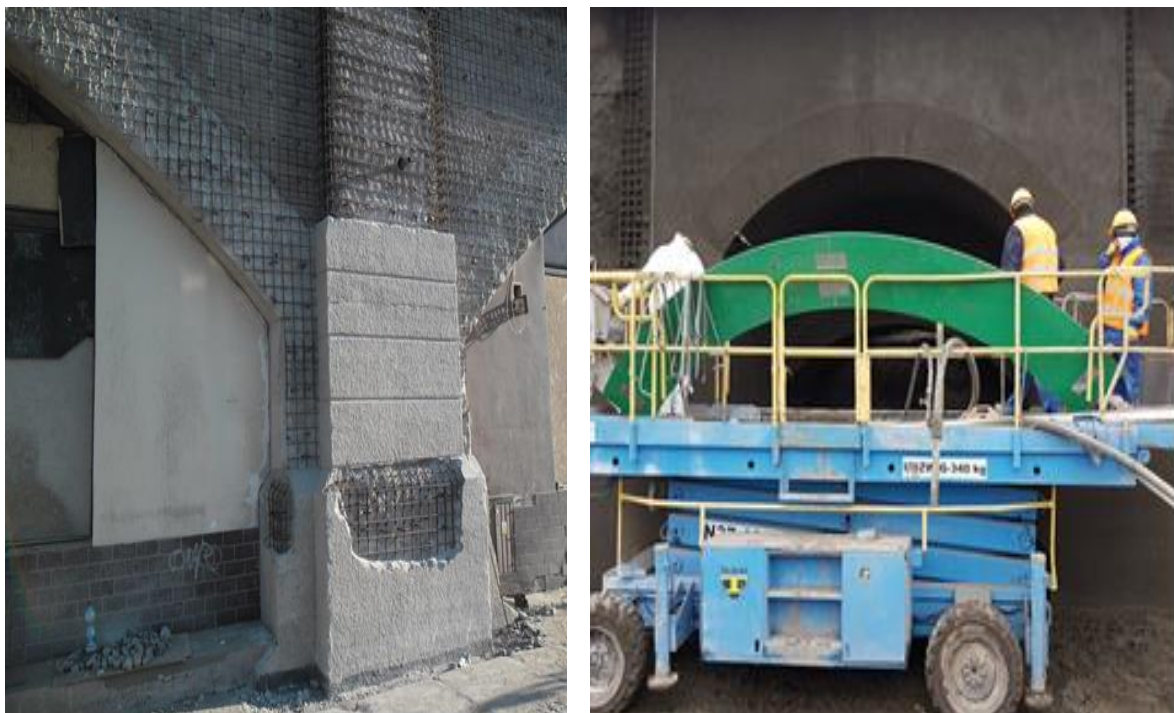
Figure 8: Preparation and reinforcement of the surface in the area of support of the flyover arch with damaged rustication. Visible green template used to imprint the arch in the fresh concrete

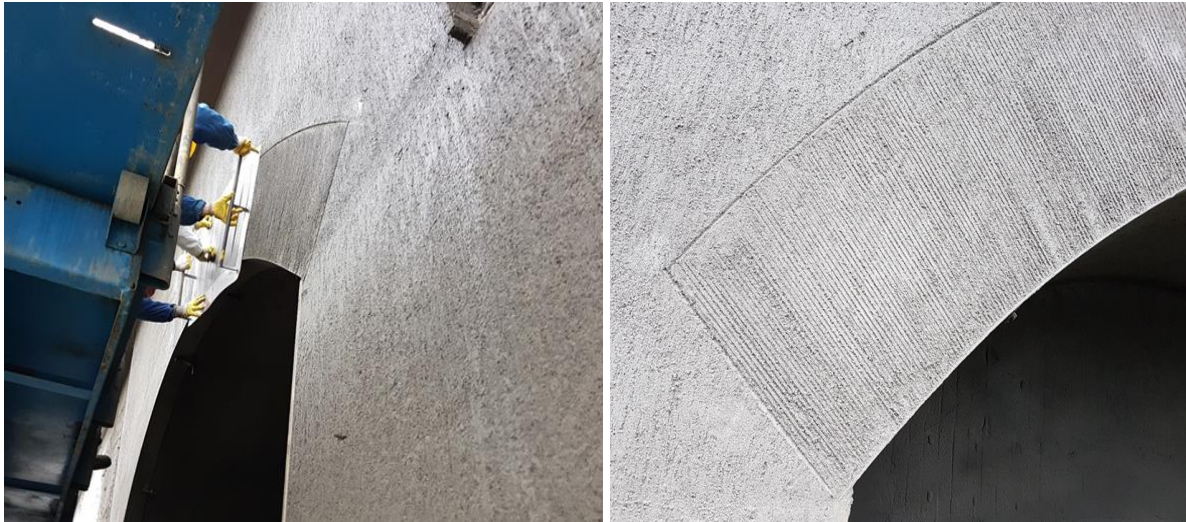
*Figure 9: Grooving the lower part of the arch - steel sheath with vertical cuts and manual line profiling*

The concrete surface was finished with the "cut and flash" technique, obtaining an incised texture, similar to natural stone blocks. Span arches and rustication of supports were also processed. Concrete external surfaces were protected with sprayed hydrophobic coatings and light yellow anti-graffiti coatings.

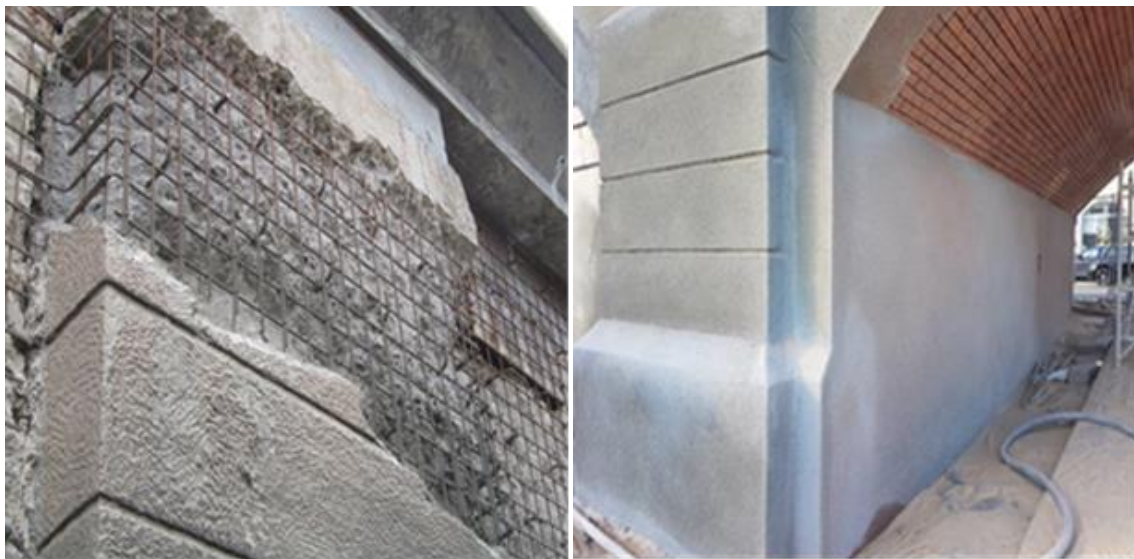
*Figure 10: Damaged rustication of the support before and after repair. Visible brick vault repair*

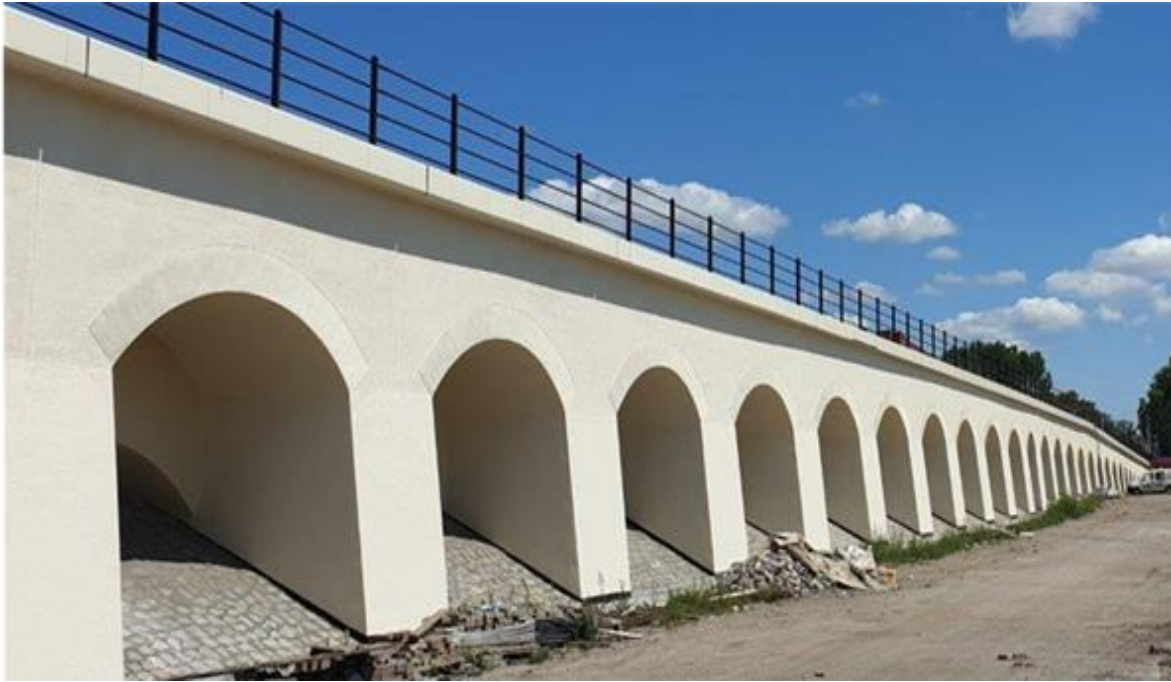
*Figure 11: View of repaired flyover*
